NATIONAL TRANSPORTATION SAFETY BOARD

MATERIALS LABORATORY FACTUAL REPORT

Report No. 18-042

Place : Dupont, Washington
Date : December 18, 2017
Vehicle : Amtrak 501, Talgo articulated passenger train
NTSB No. : RRD18MR001
Investigator : Michael Hiller

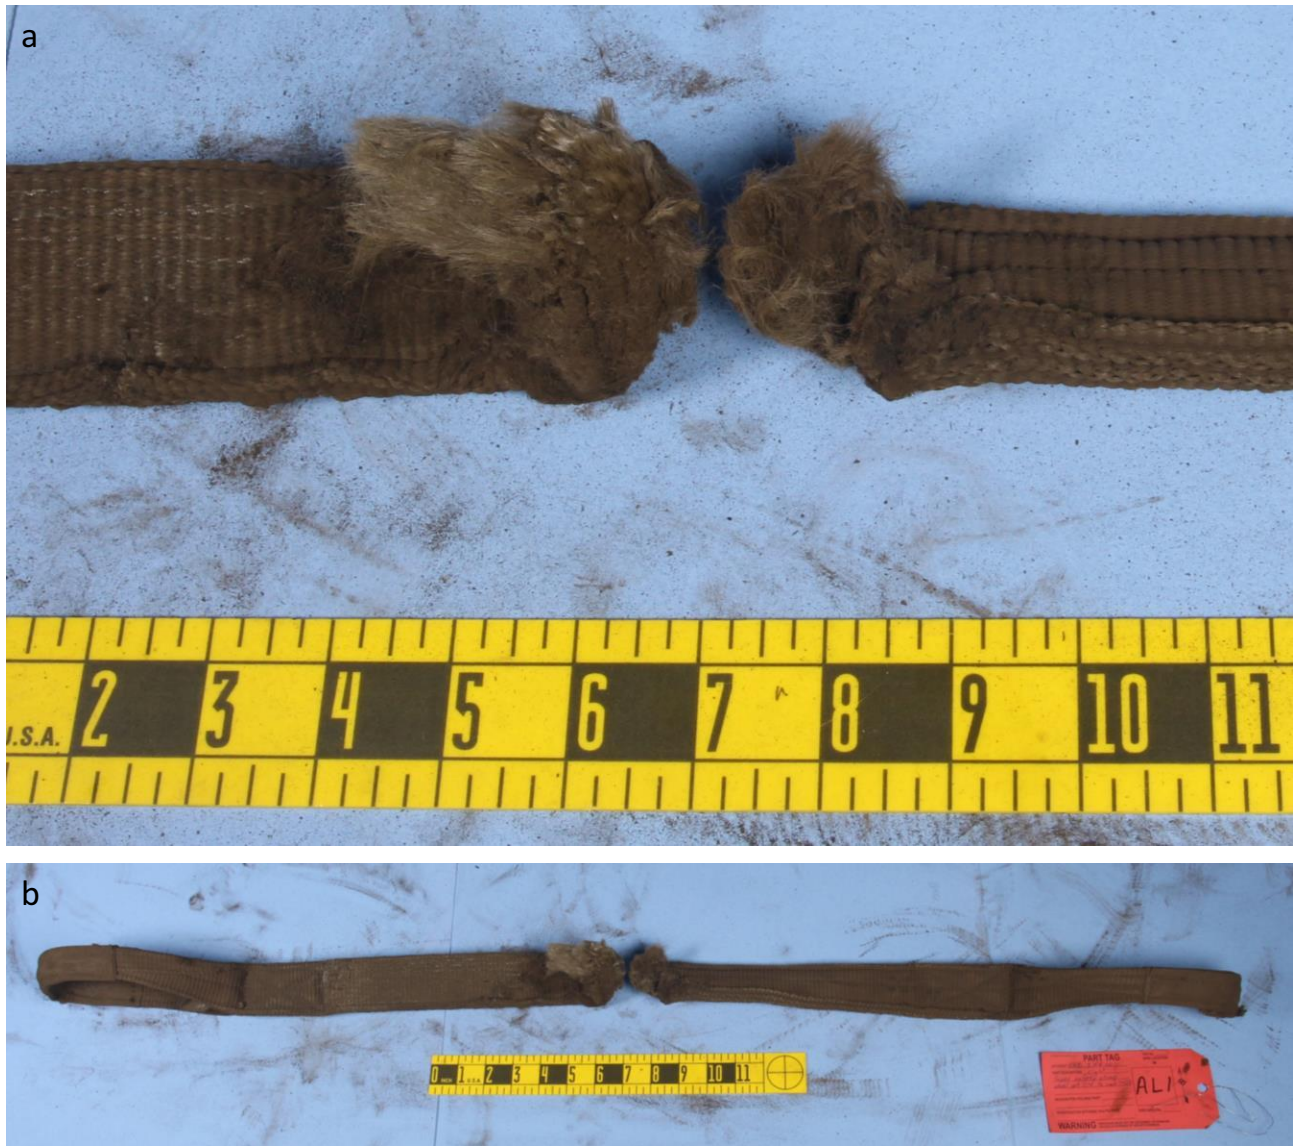
Figure 5 Images after tension testing of web sling AL1 from car 7423, right side. Image (a) is a close view of the fracture region. Image (b) is an overall view of the fractured web sling.

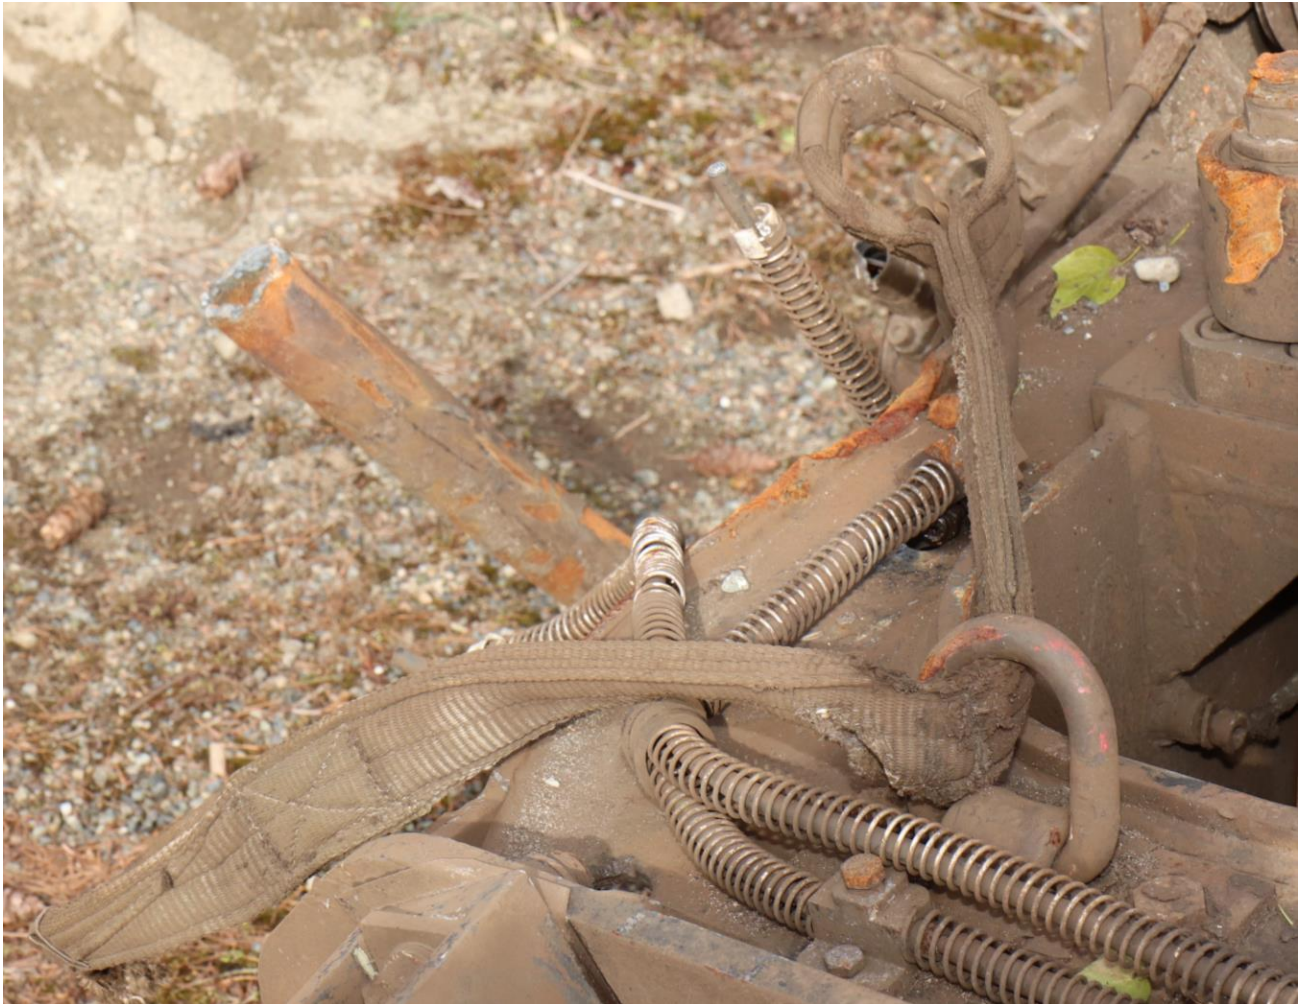
Figure 6 Image of the AL1 web sling on the rolling assembly for car 7423, right side.

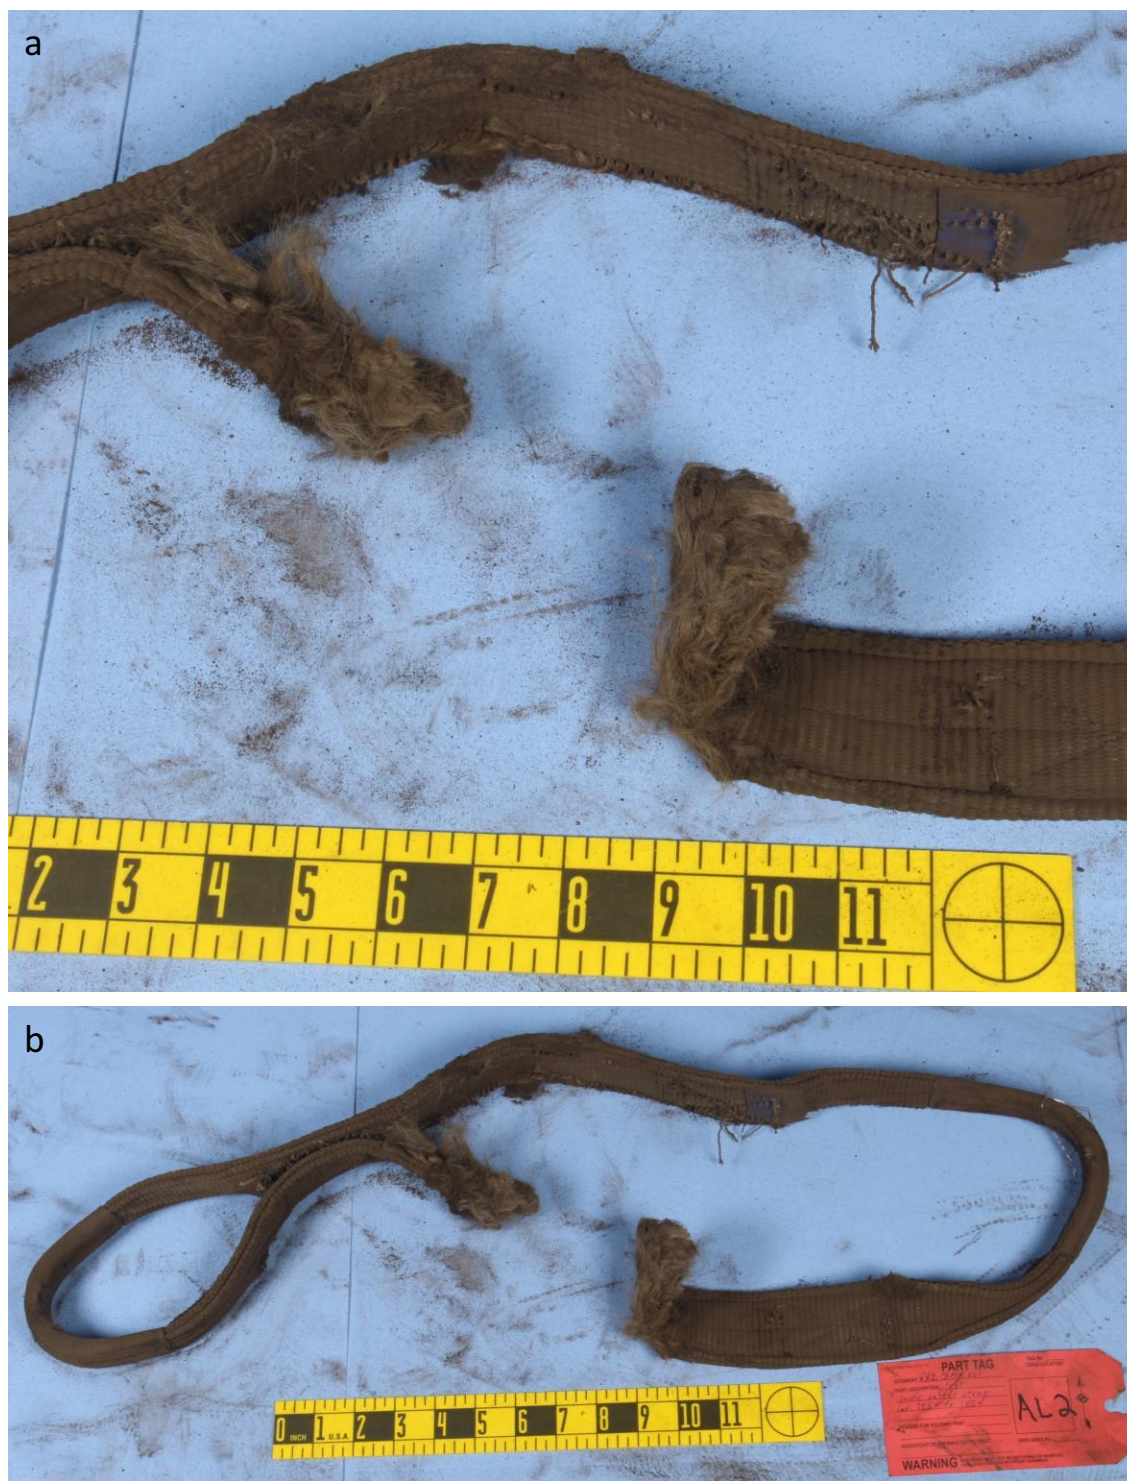
Figure 7 Images after tension testing of web sling AL2 from cars 7554 to 7454, left side. Image (a) is a close view of the fracture region. Image (b) is an overall view of the fractured web sling.

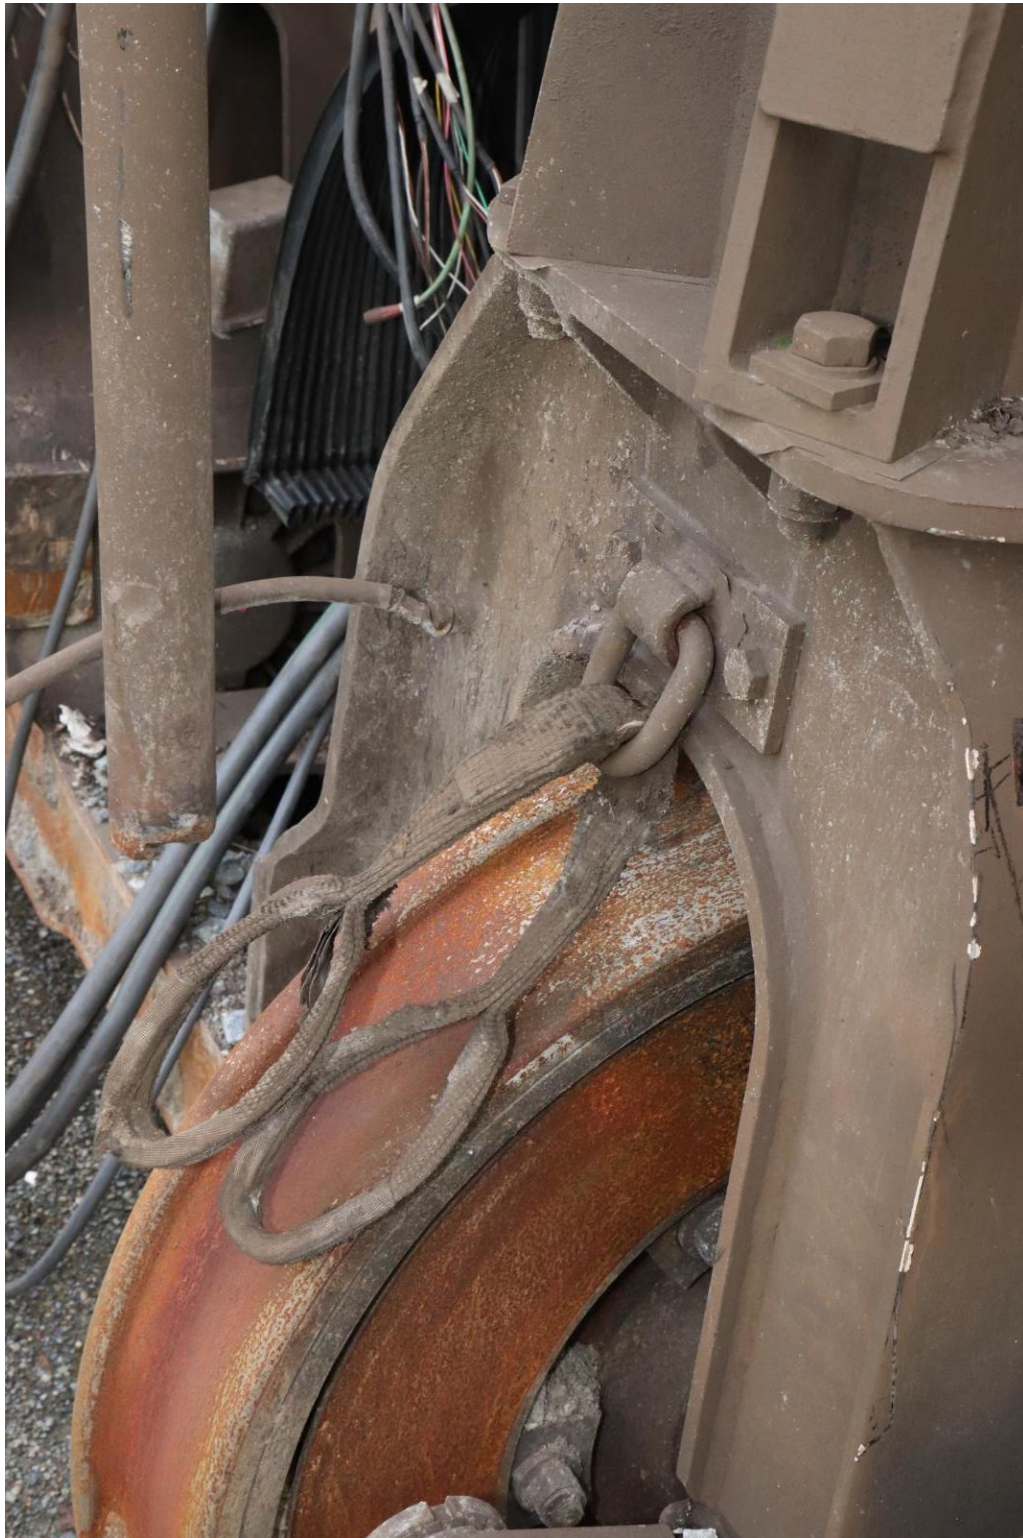
Figure 8 Image of web sling AL2 on the wheel assembly for car 7554, left side.

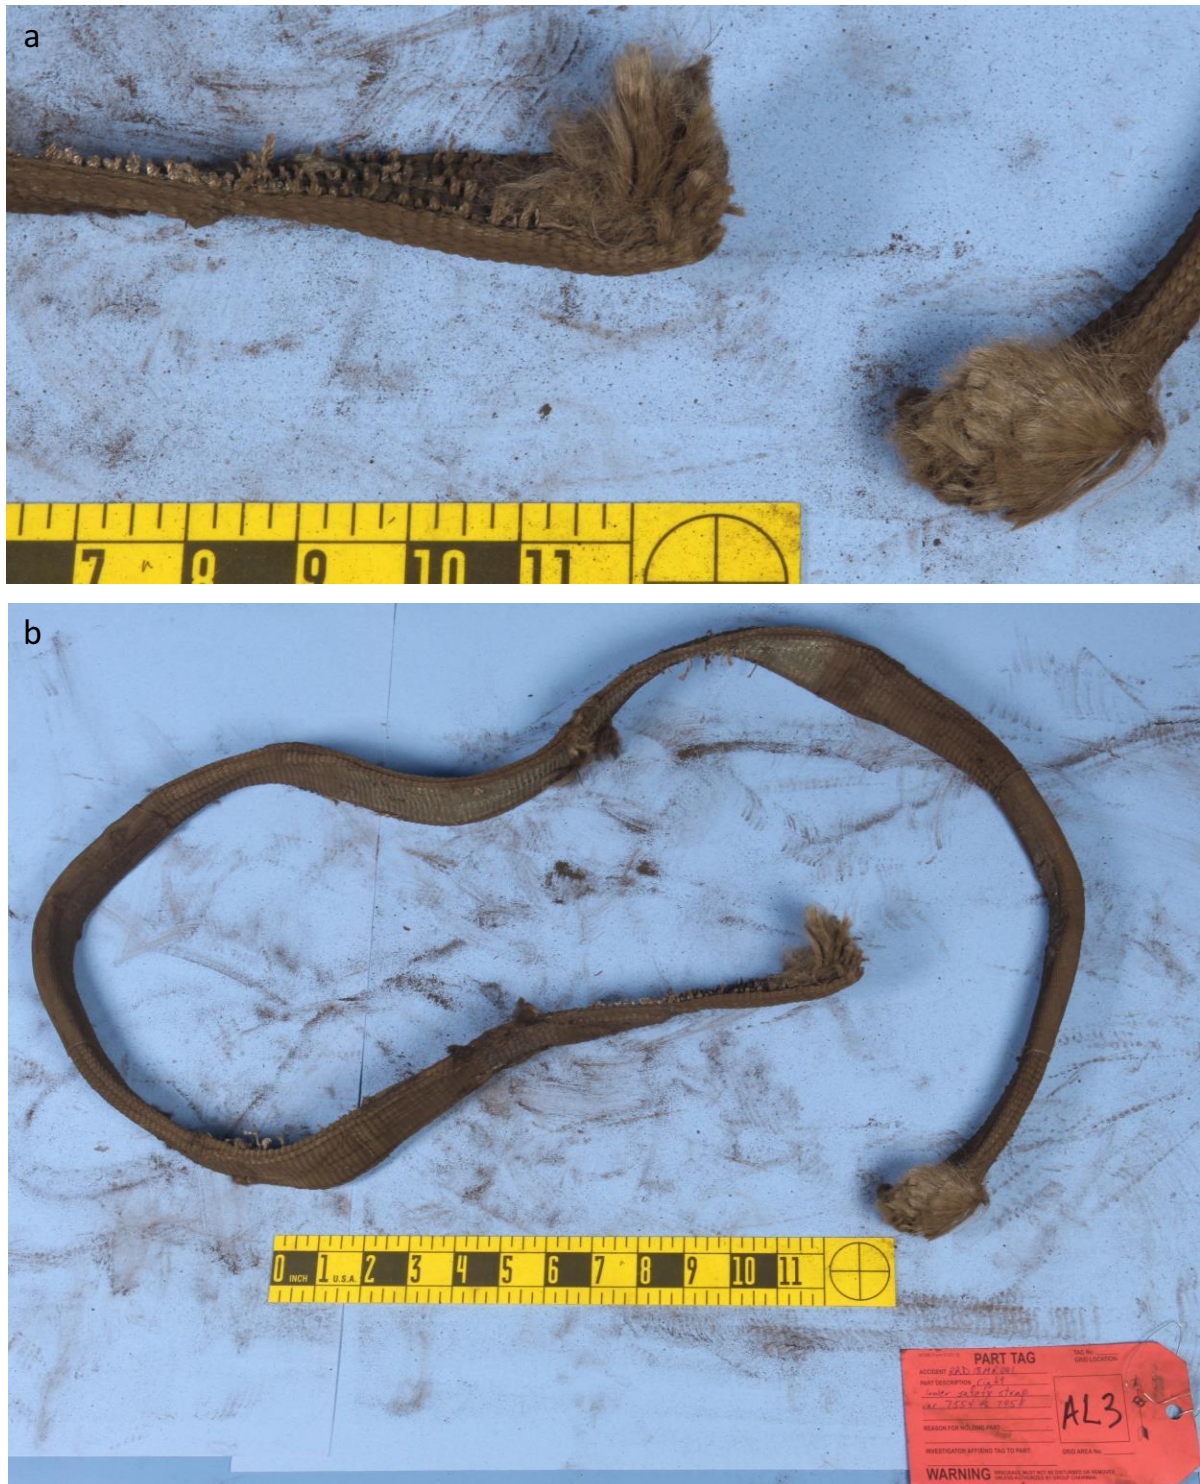
Figure 9 Images after tension testing of web sling AL3 from cars 7554 to 7454, right side. Image (a) is a close view of the fracture region. Image (b) is an overall view of the fractured web sling.

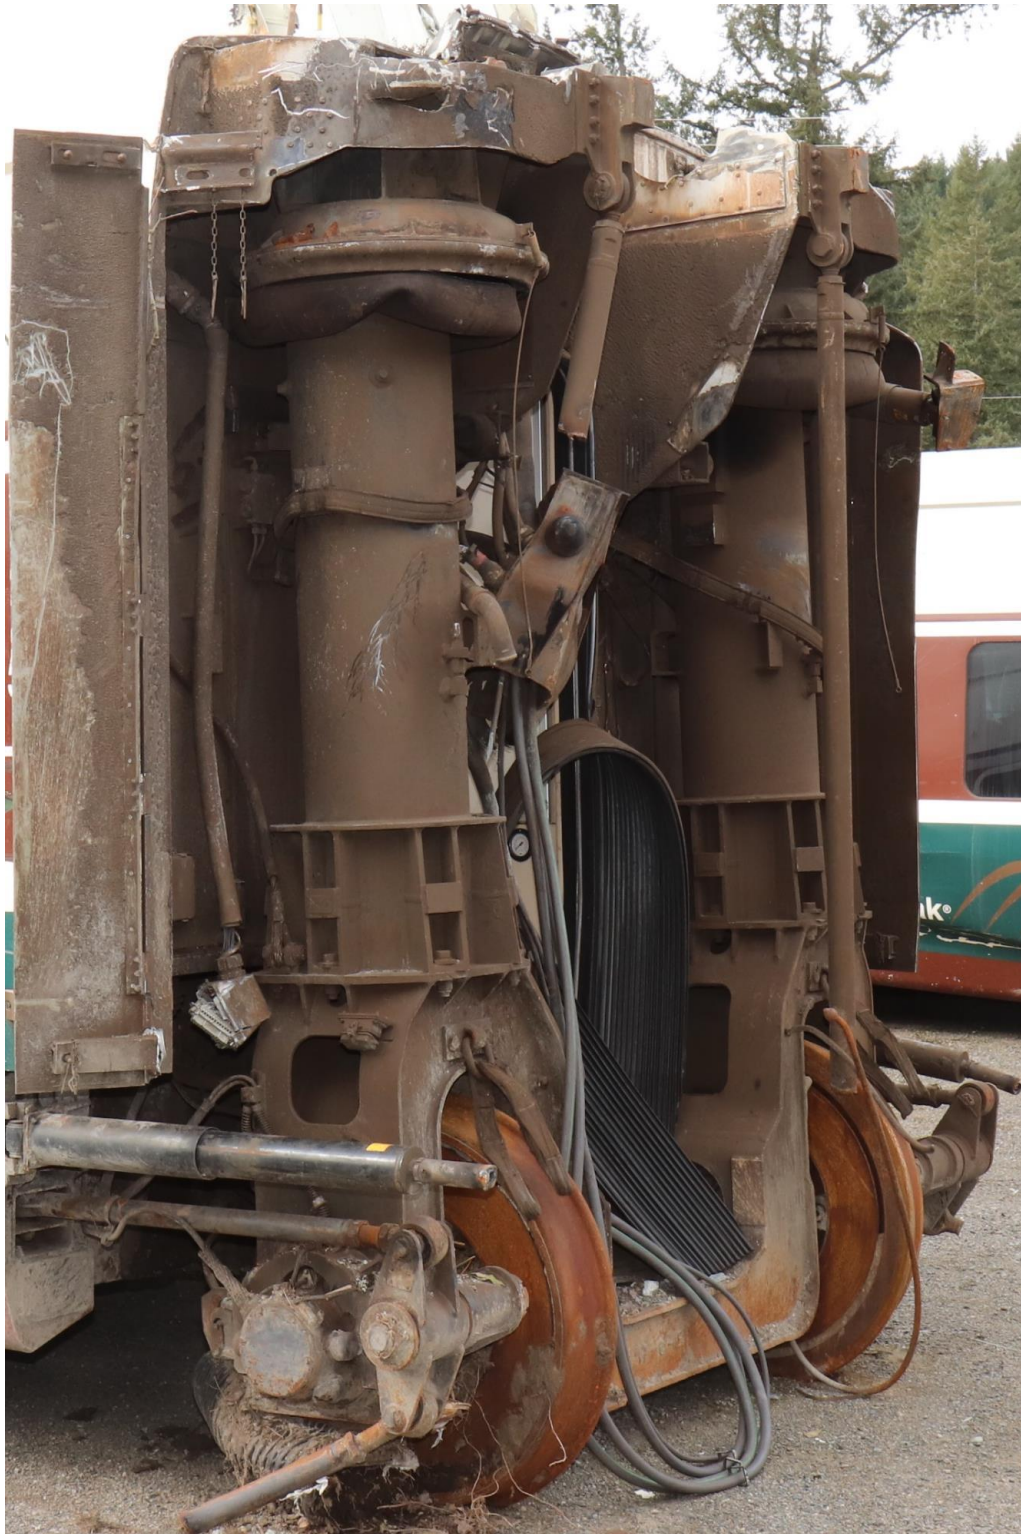
Figure 10 Image of web sling AL3 on car 7554, right side.

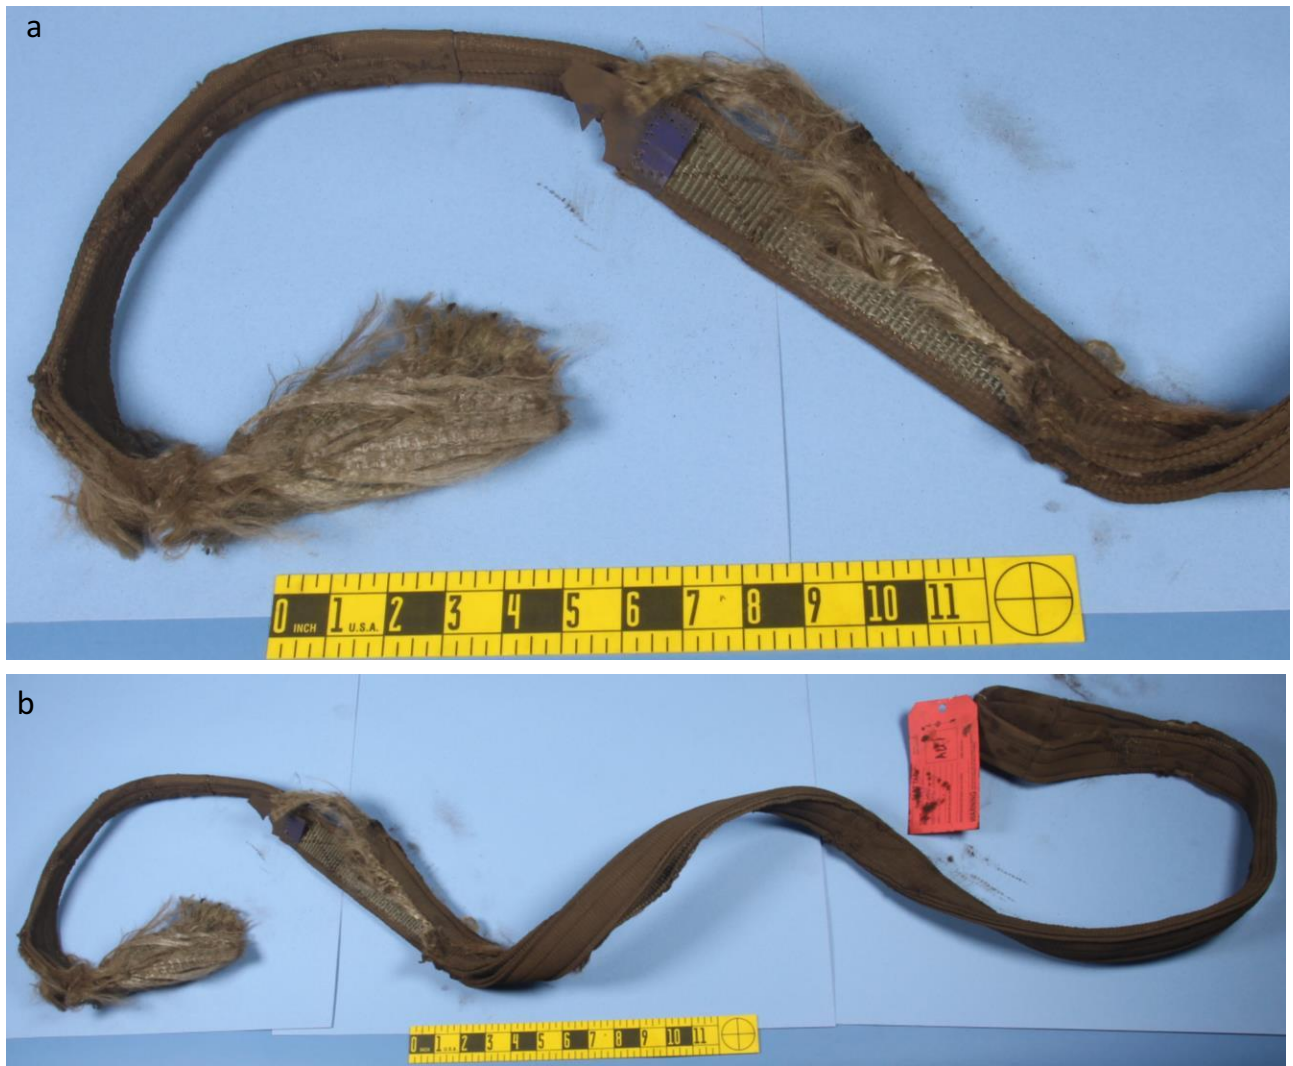
Figure 11 Images after tension testing of web sling AU1 from car 7102, left side. Image (a) is a close view of the fracture region. Image (b) is an overall view of the fractured web sling.

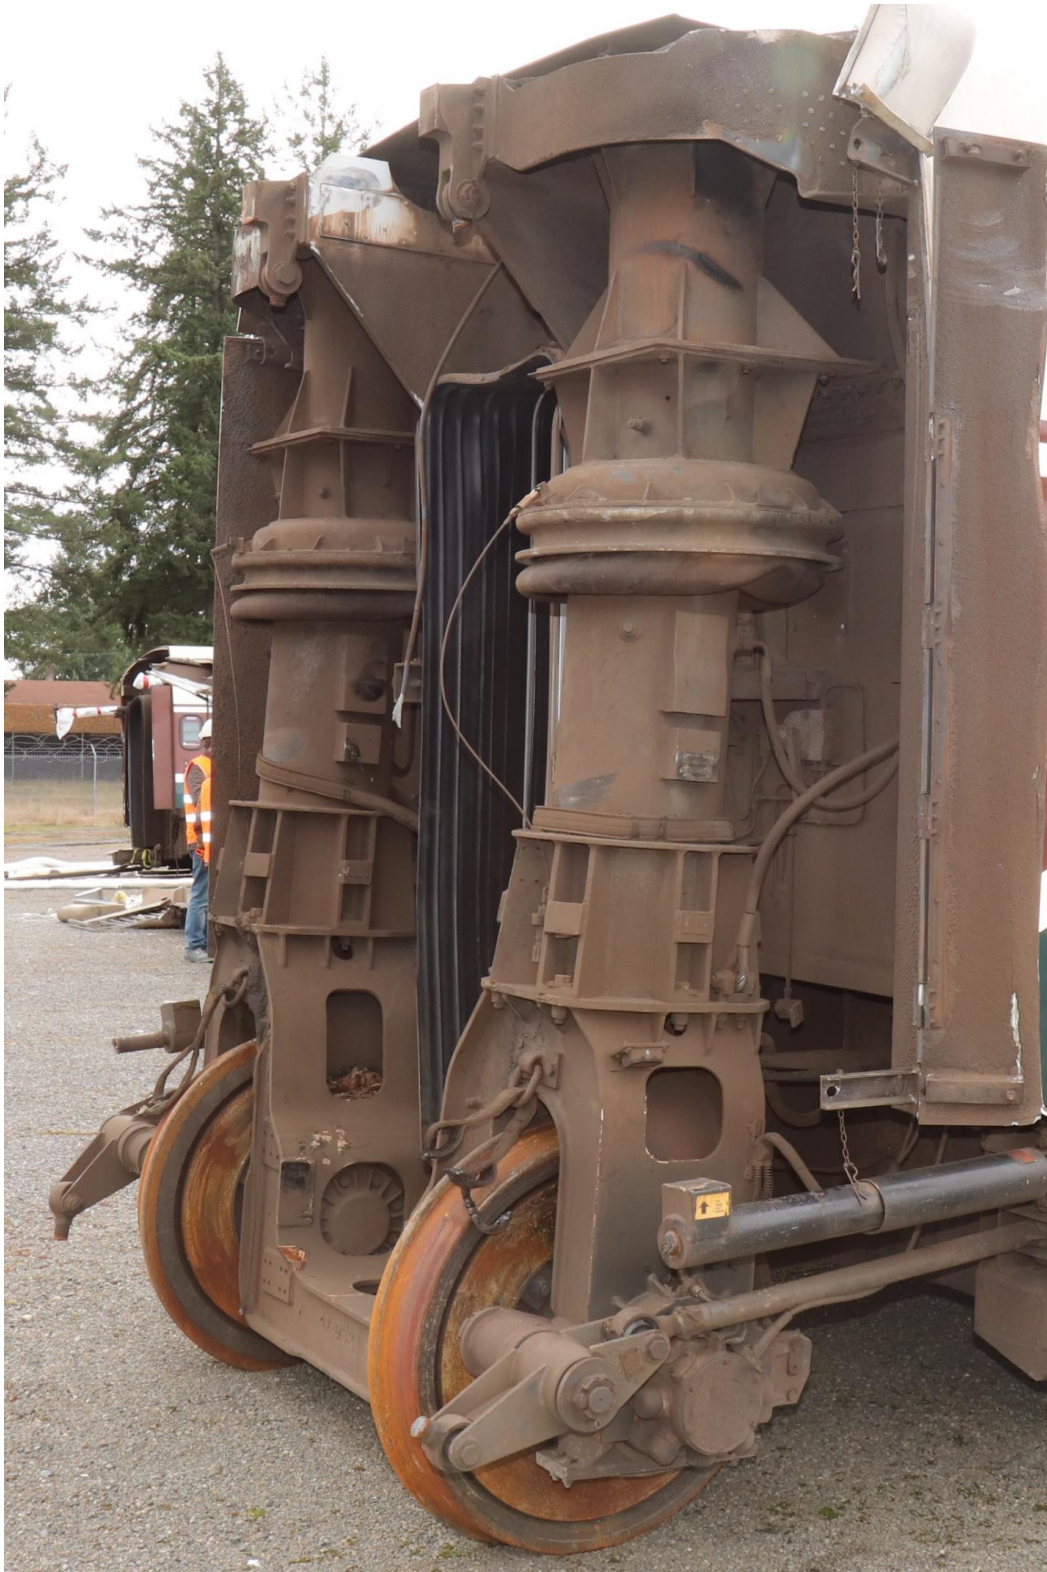
Figure 12 Image of web sling AU1 on car 7102, left side.

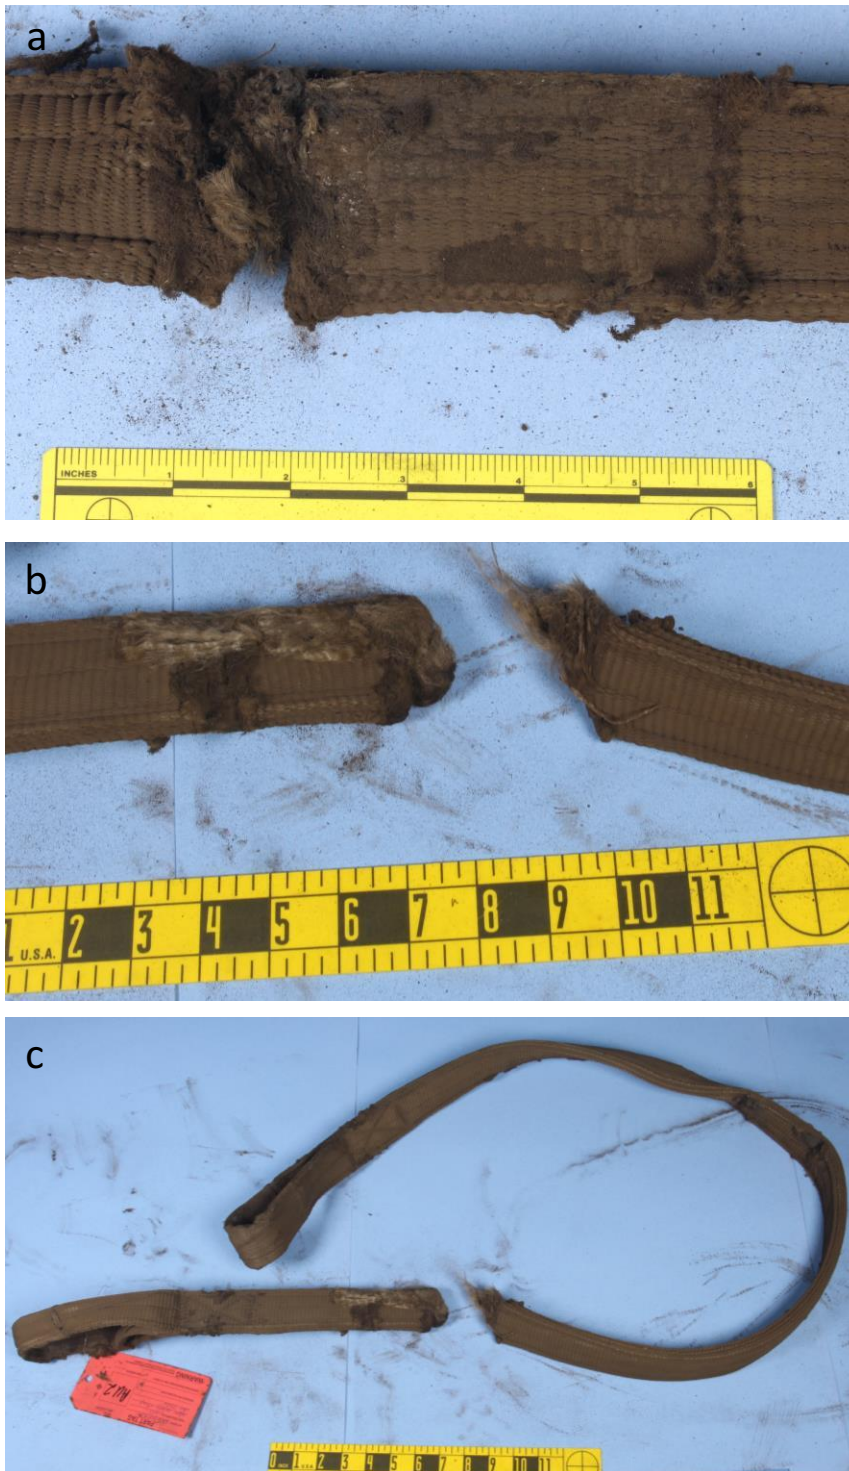
Figure 13 Images before and after tension testing of web sling AU2 from car 7420, left side. Image (a) is a worn area prior to tension testing. Image (b) is a close view of the fracture region. Image (c) is an overall view of the fractured web sling.

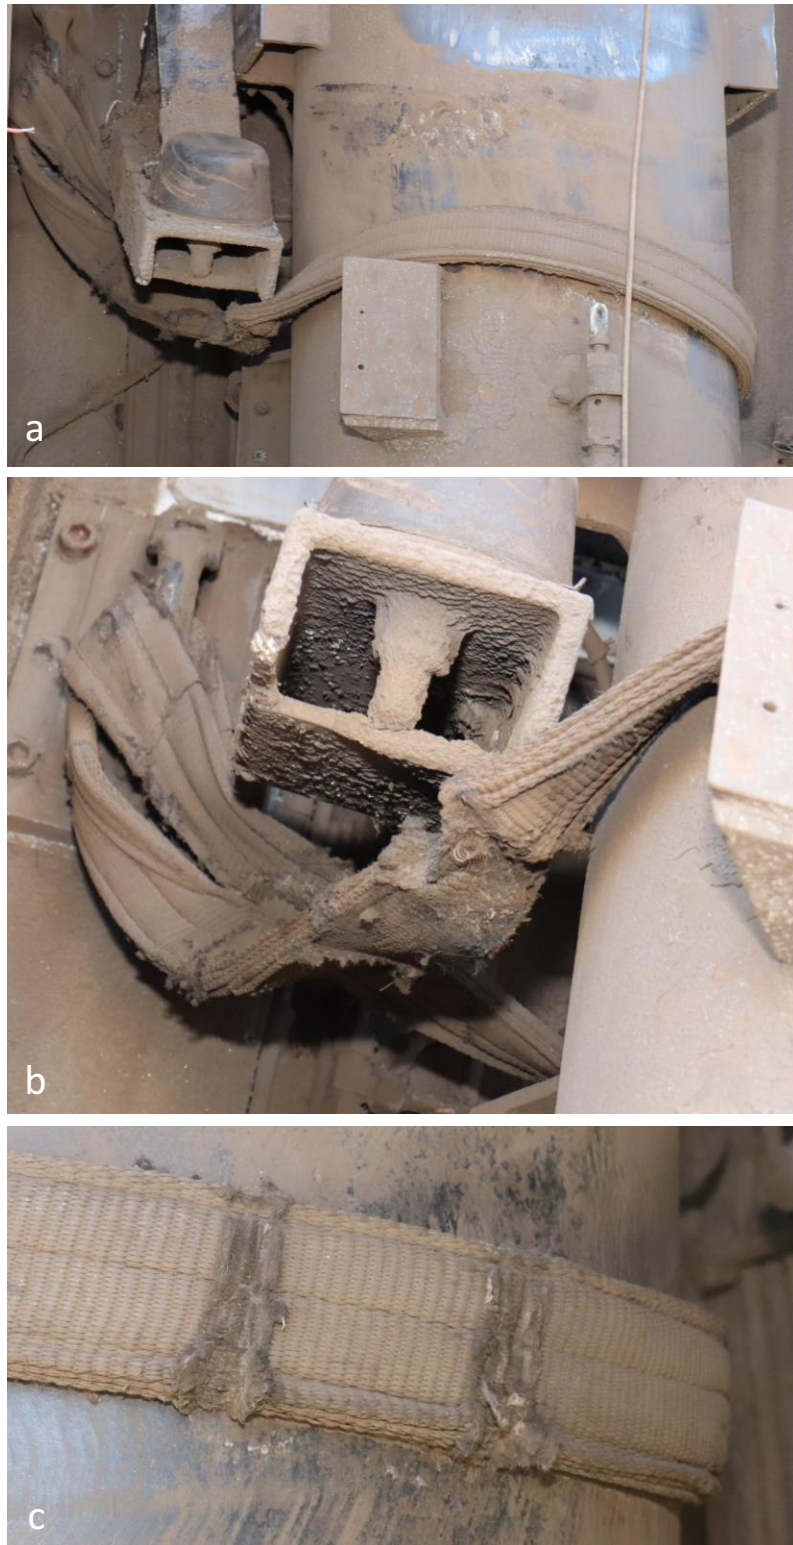
Figure 14 Image of web sling AU2 on car 7420, left side.

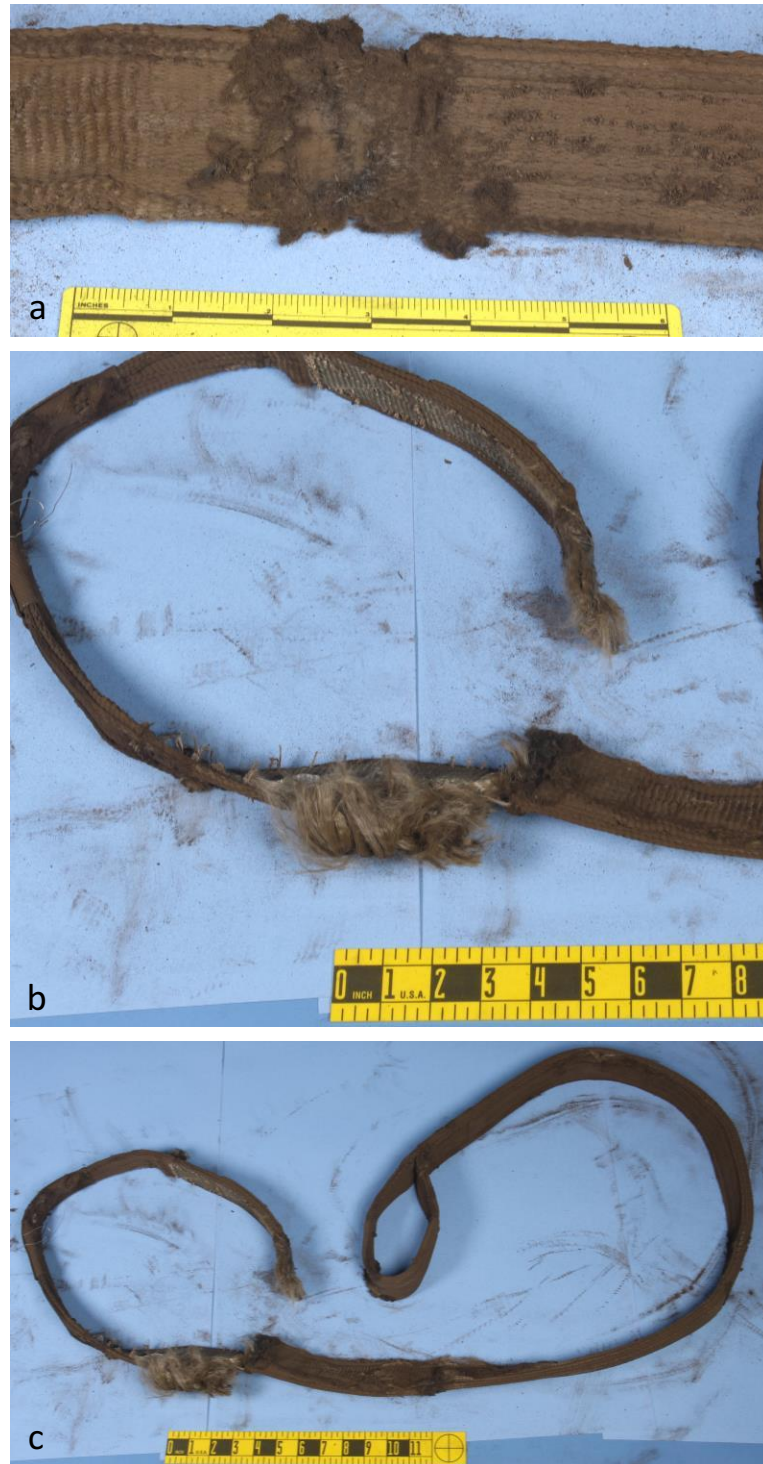
Figure 15 Images before and after tension testing of web sling AU3 from car 7420, right side. Image (a) is a worn area prior to tension testing. Image (b) is a close view of the fracture region. Image (c) is an overall view of the fractured web sling.

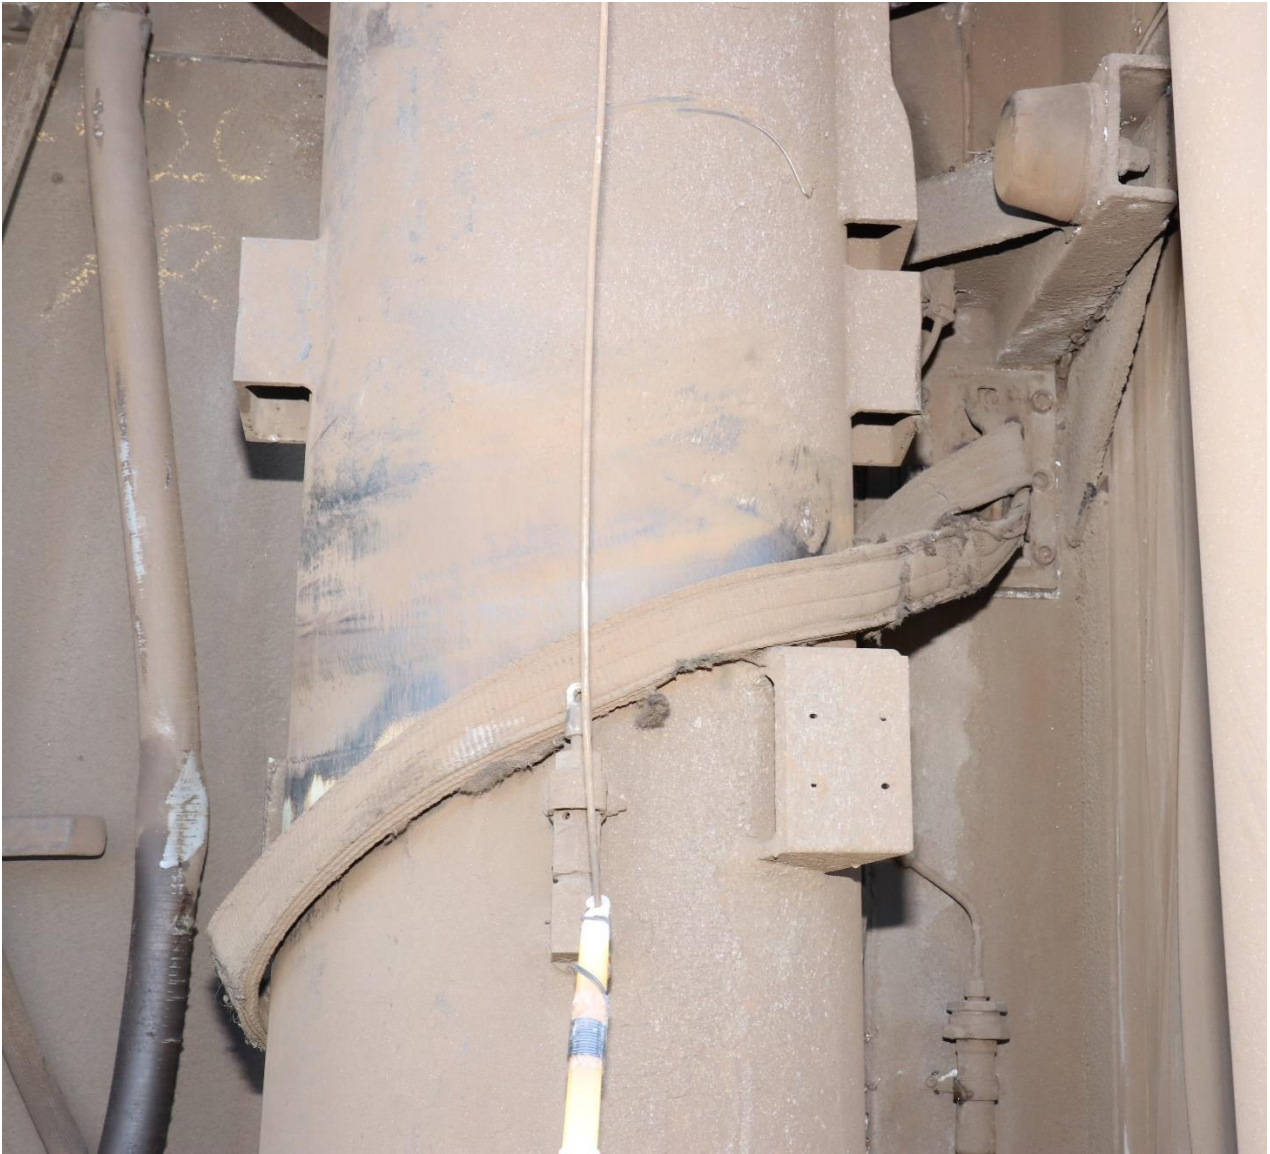
Figure 16 Image of web sling AU3 on car 7420, right side.

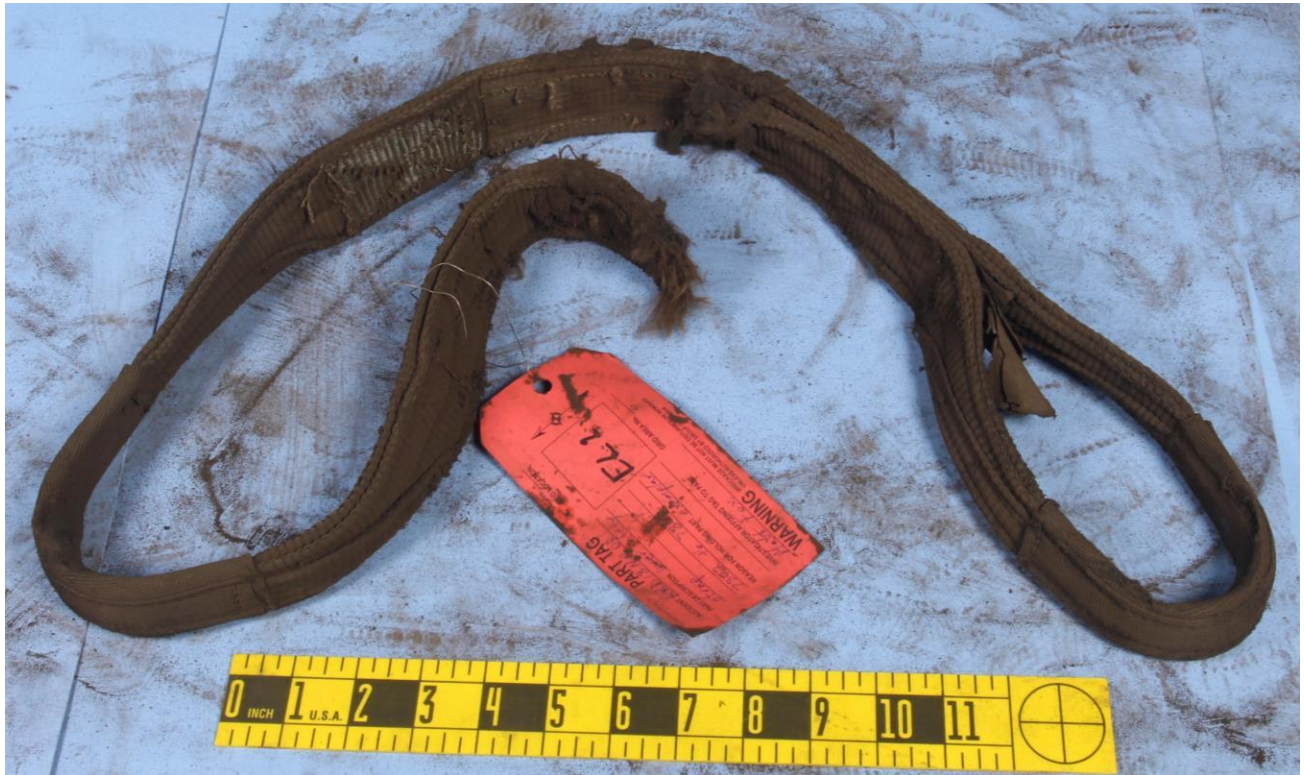
Figure 17 Image after tension testing of web sling EL1 from car 7302 to 7802, left side.

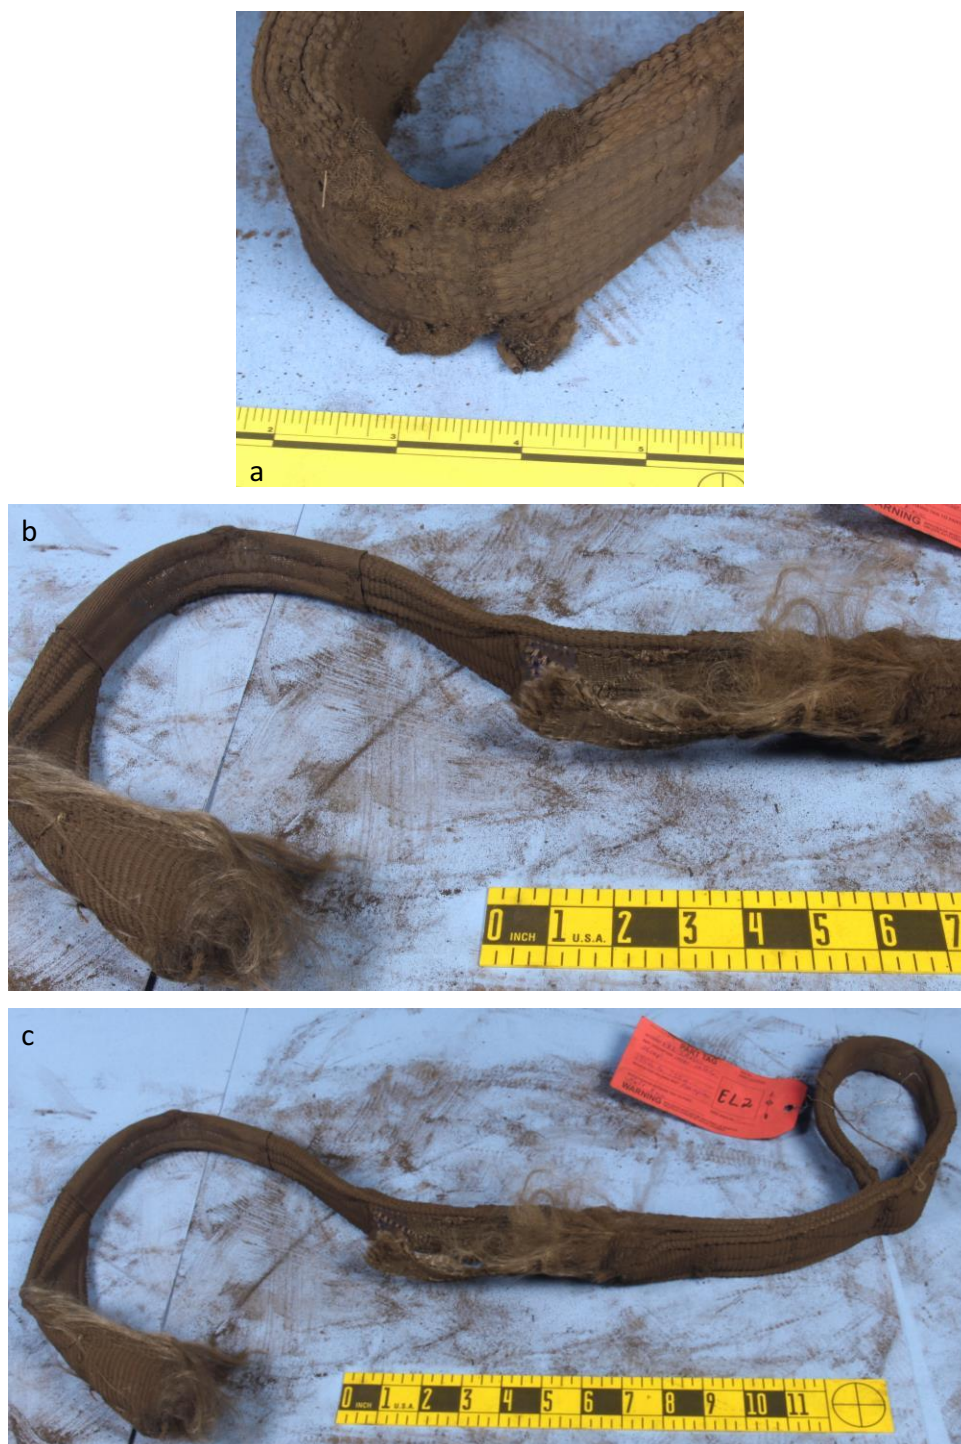
Figure 18 Images before and after tension testing of web sling EL2 from car 7802 to 7552, left side. Image (a) is a worn area prior to tension testing. Image (b) is a close view of the fracture region. Image (c) is an overall view of the fractured web sling.

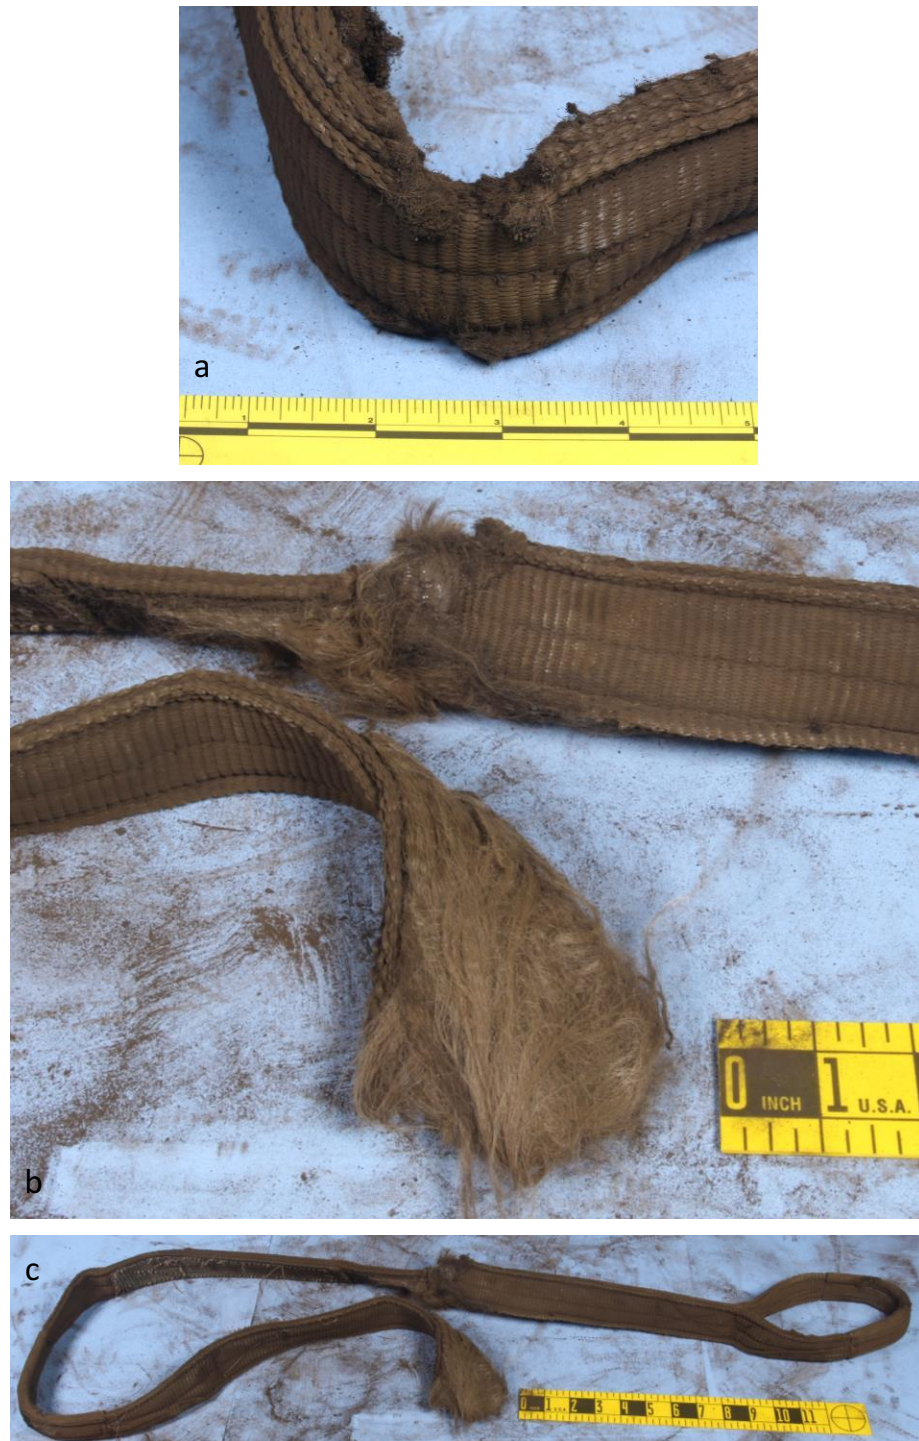
Figure 19 Images before and after tension testing of web sling EL3 from car 7802, right side. Image (a) is a worn area prior to tension testing. Image (b) is a close view of the fracture region. Image (c) is an overall view of the fractured web sling.

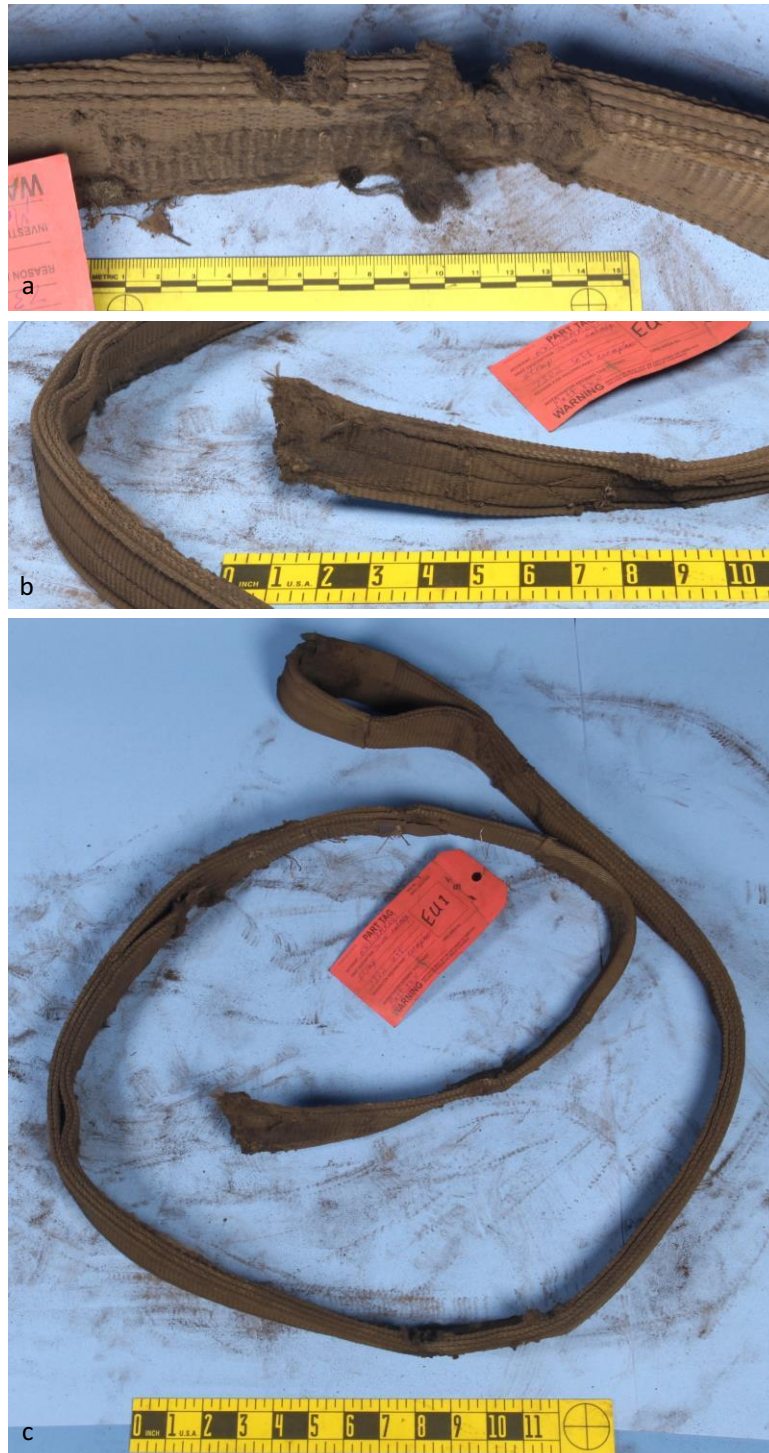
Figure 20 Images before and after tension testing of web sling EU1 from car 7302, left side. Image (a) is a worn area prior to tension testing. Image (b) is a close view of the fracture region. Image (c) is an overall view of the fractured web sling.
